## **Preliminary Evaluation of Water Quality in the Vicinity of San Juan Generating Station and Recommended Corrective Actions**

PRELIMINARY INVESTIGATION INTO THE  
HYDROLOGIC CHARACTERISTICS  
OF THE  
WESTWATER AND SHUMWAY ARROYOS  
IN THE VICINITY OF THE  
SAN JUAN GENERATING STATION  
SAN JUAN COUNTY, NEW MEXICO

PREPARED BY  
METRIC CORPORATION  
LOS LUNAS, NEW MEXICO

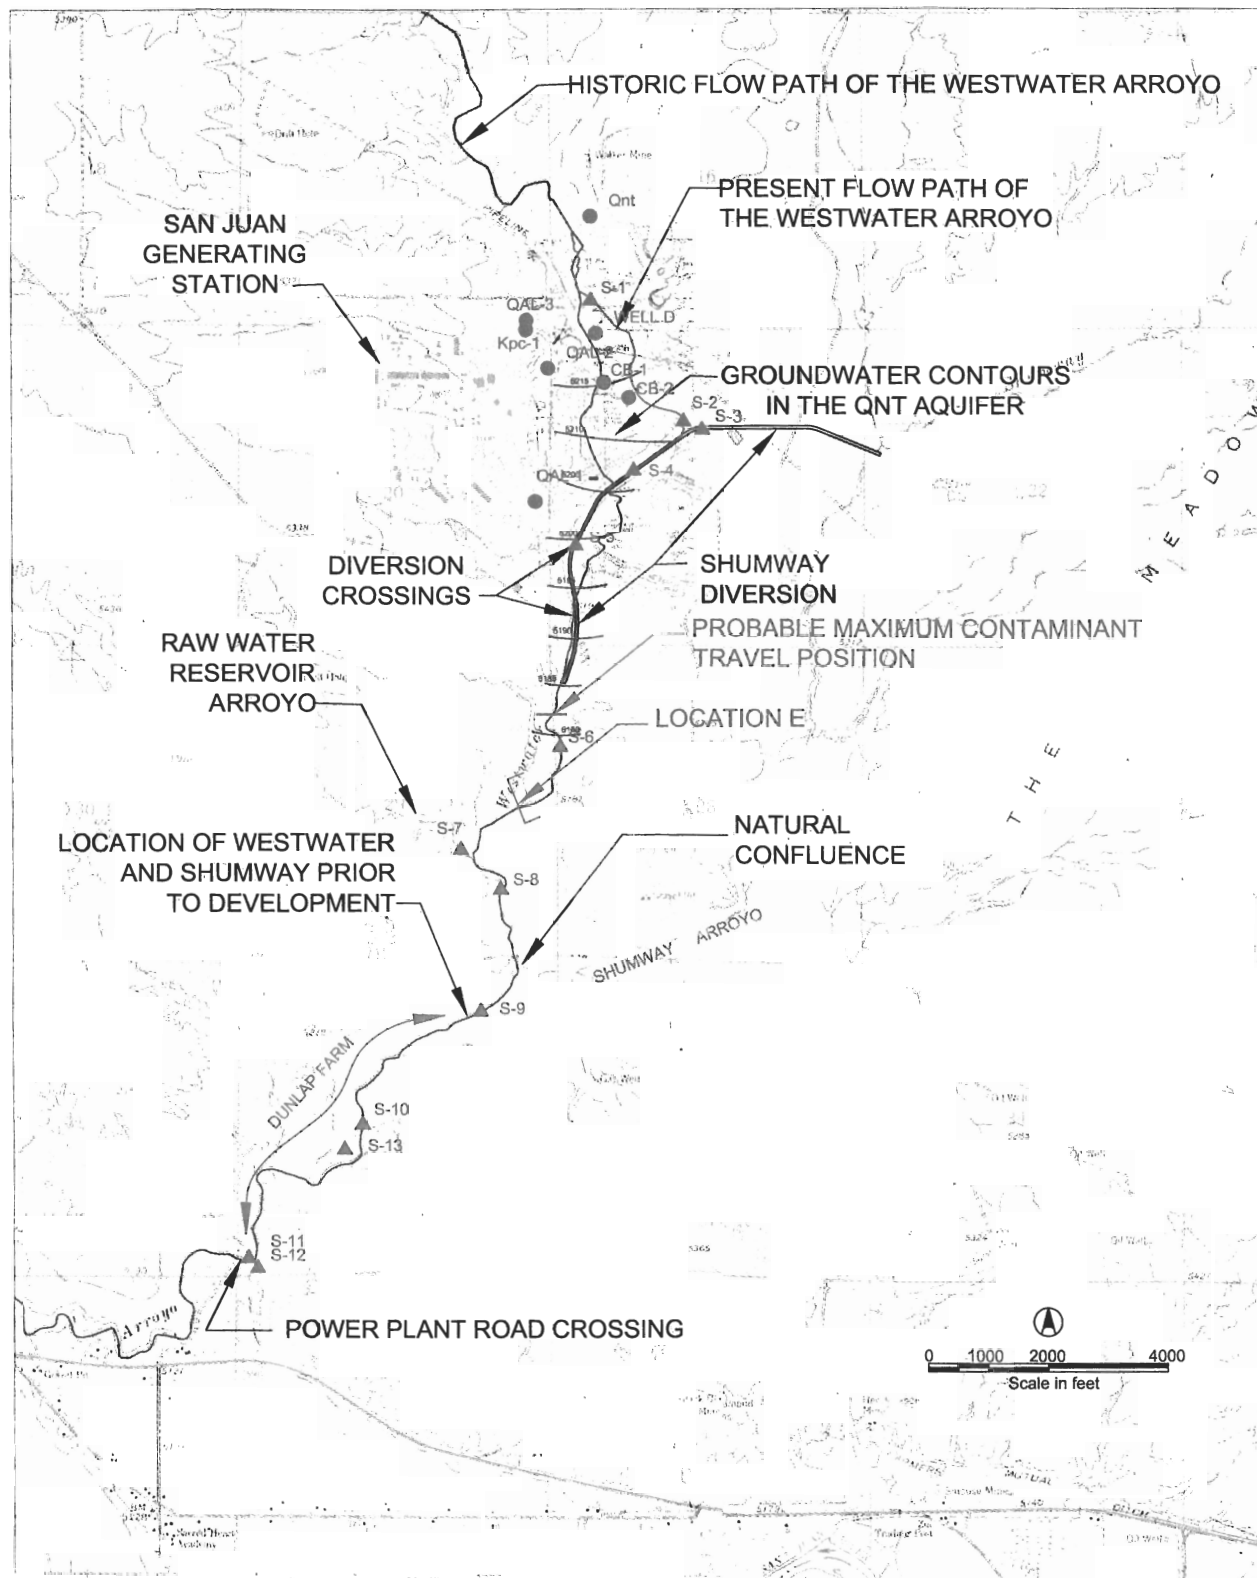
**FIGURE 2**  
**PROPOSED RECOVERY TRENCH**  
**LOCATION MAP**

The Qnt aquifer is a linear saturated unconsolidated deposit, which generally follows the historic flow path of the Westwater Arroyo and then the flow path of the Shumway Arroyo downstream from the natural confluence (FIGURE 2). The aquifer is about 1000 feet wide and 20 feet thick in the vicinity of the San Juan Generating Station.

The recommended corrective actions to address underground leakage at the San Juan Generating Station consist of the corrective actions listed in TABLE 4 including construction of a groundwater recovery trench at Location E which is about 4000 ft. down stream from the San Juan Generating Station along the groundwater flow path of the Qnt aquifer (FIGURE 2). The objective of the groundwater recovery trench would be to capture virtually all of the flow in the Qnt aquifer, including contributions from the San Juan Generating Station, and return the water to the process water system at the station for reuse. Location E was selected because it is downstream from the maximum distance that contaminants from San Juan Generating Station might have traveled in the Qnt aquifer based on a particle velocity of 90 ft/year and a travel time of 33 years. Additionally, it is in an undeveloped area and the Qnt aquifer is only about 250 ft. wide at that location. Also, it would not be necessary to disturb the arroyo channel to construct the recovery trench at Location E. Details of the proposed groundwater recovery trench construction are presented in FIGURE 4, 5 and 6. Preliminary estimates indicate that the total flow in the Qnt aquifer at Location E is about 16 ac.ft/yr.

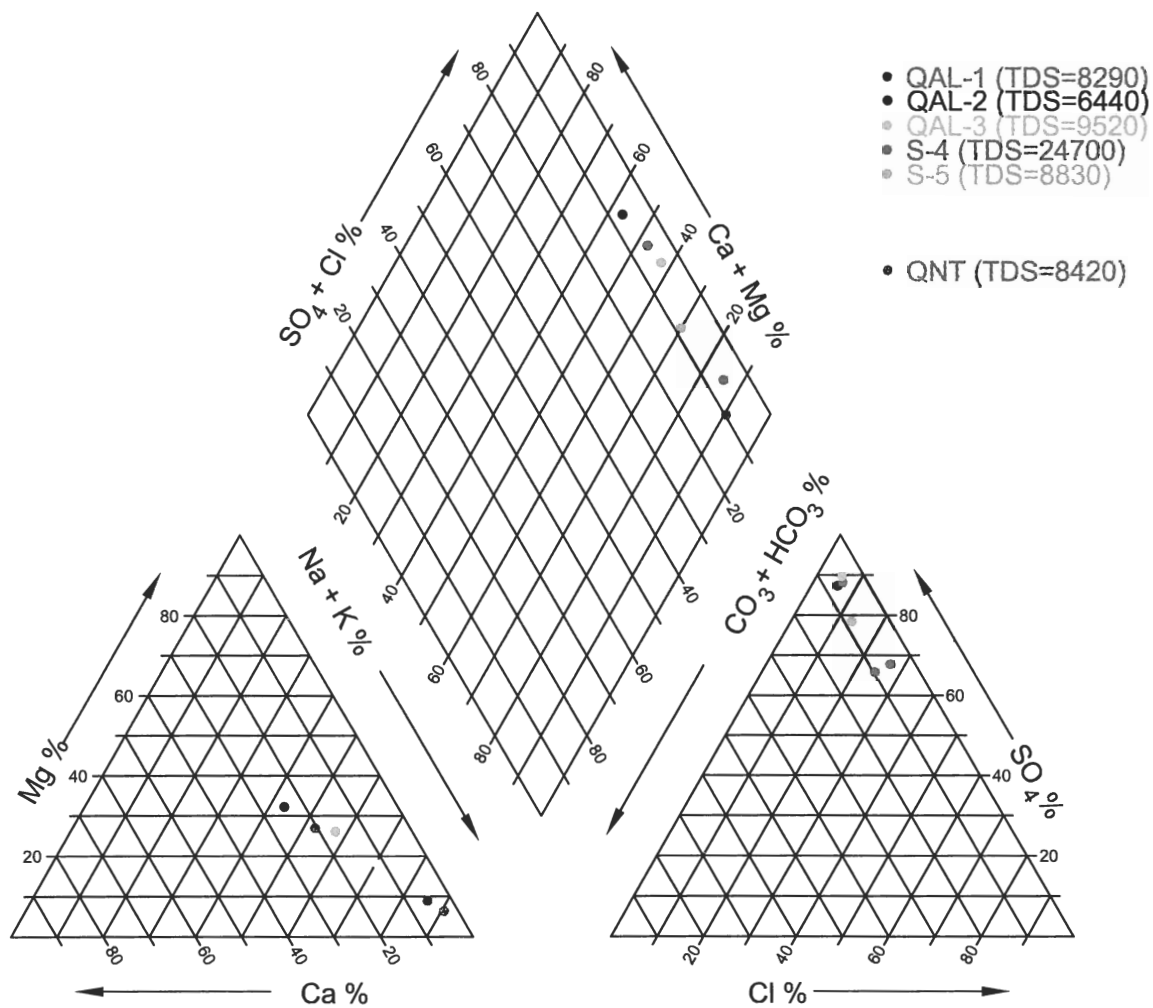
FIGURE 3  
TRILINEAR DIAGRAM

Recent water quality data for the monitoring wells and surface water sampling sites discussed above have been plotted on FIGURE 3. A preliminary analysis of FIGURE 3 suggests that the waters at S-4 and S-5 are mixtures of the upstream Qnt aquifer water represented by the QNT sample and groundwater flow coming from the Generating Station area represented by the Qal-1, 2 and 3 samples, because the S-4 and S-5 samples plot between QNT and Qal-1, 2 and 3.

The variations in TDS along the groundwater flow path can be explained by concentration of salts by evapotranspiration and dilution by the tributary flows along the flow path.

In summary, the data presented provides us with reasonable confidence that the water sampled at S-4 and S-5 contains a component of groundwater coming from the Generating Station area.

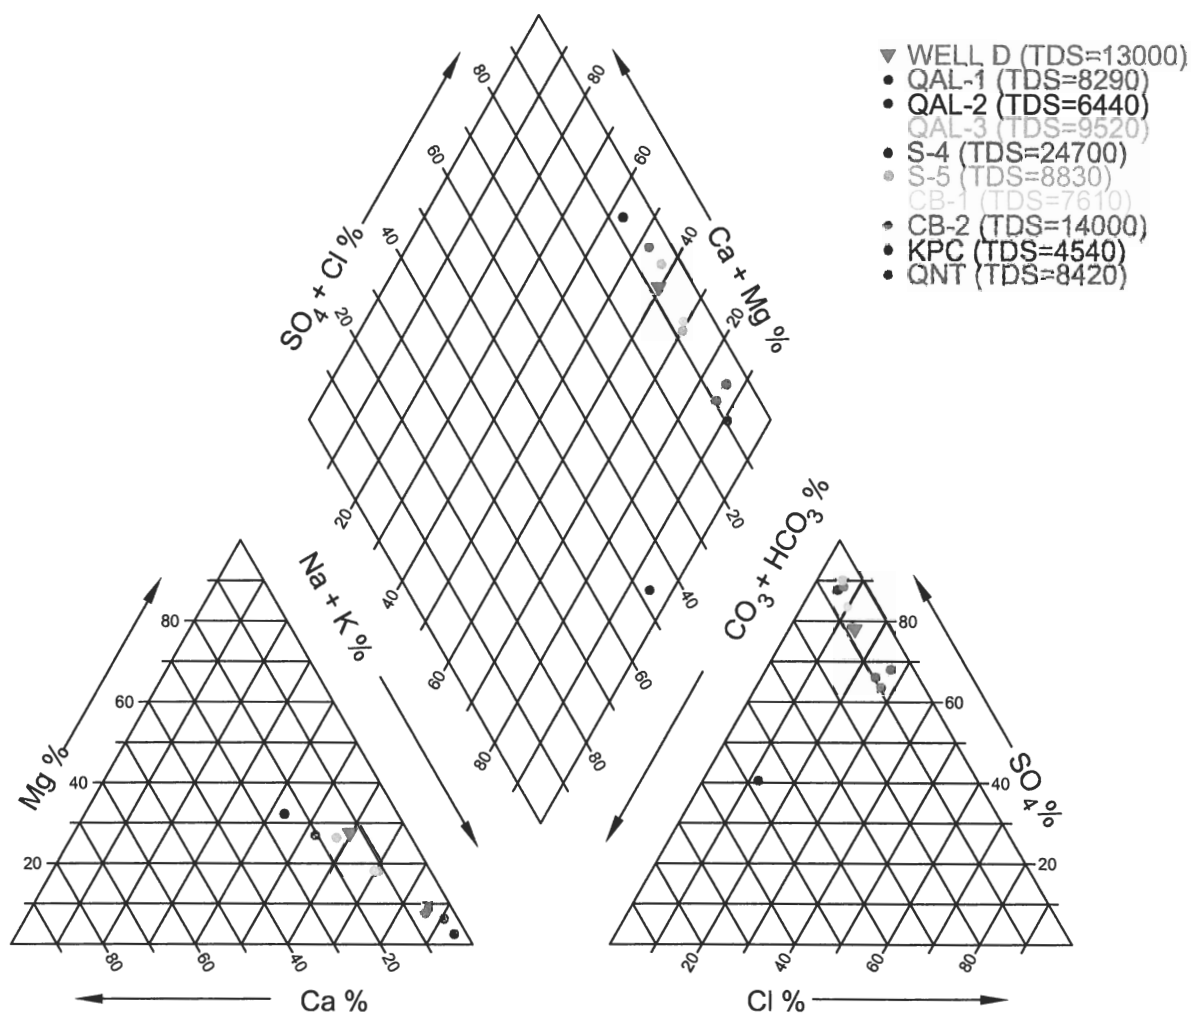
FIGURE 2  
TRILINEAR DIAGRAM

Recent water quality data for the monitoring wells and surface water sampling sites discussed above have been plotted on FIGURE 2. The supporting water quality data is in APPENDIX B. A preliminary analysis of FIGURE 2 suggests that the waters at Well D, CB-1, S-5 S-4 and CB-2 are all mixtures of the upstream Qnt aquifer water represented by the Qnt sample and groundwater flow coming from the Generating Station area represented by the Qal-1, 2 and 3 samples, because the Well D, CB-1, S-5, S-4 and CB-2 samples all plot on a straight line between Qnt-1 and Qal-1, 2 and 3. The variations in TDS along the groundwater flow path can be explained by concentration by evapotranspiration and dilution by the tributary flow along the flow path.

In summary, the data presented provides us with reasonable confidence that the water sampled at S-4 and S-5 contains a component of groundwater coming from the Generating Station area.
